TECH NOTICE for Great Planes FlatOut CAP 580

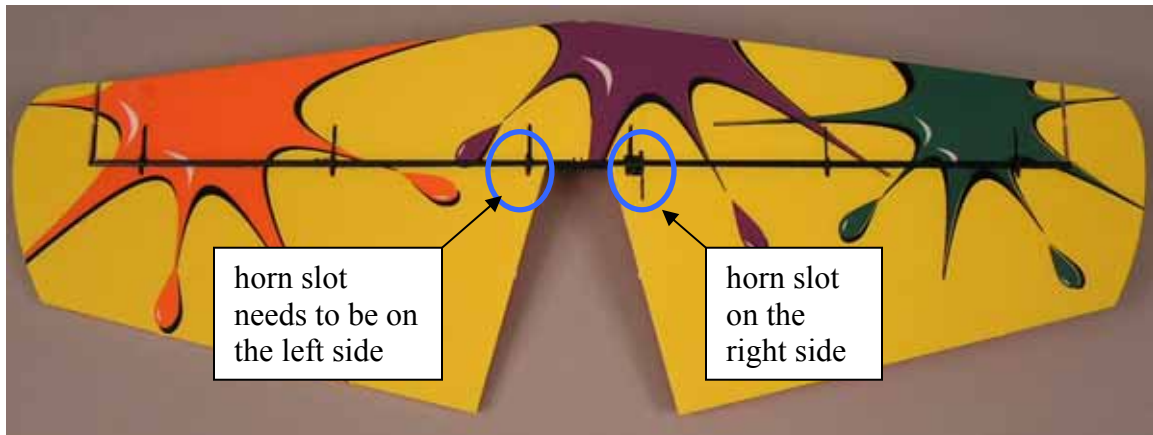
In some cases, the elevators of the FlatOut CAP 580 have the control horn slot cut on the wrong side. In order for the precut pushrods to work with the elevator and rudder, the horn needs to be on the left. If your control horn is on the right side of the elevator as shown in the photo below, use the following steps to correct the problem. These steps can be performed even if the tail is already glued into the fuselage.
