SEQUENCE 1.20

MANUAL ADDENDUM

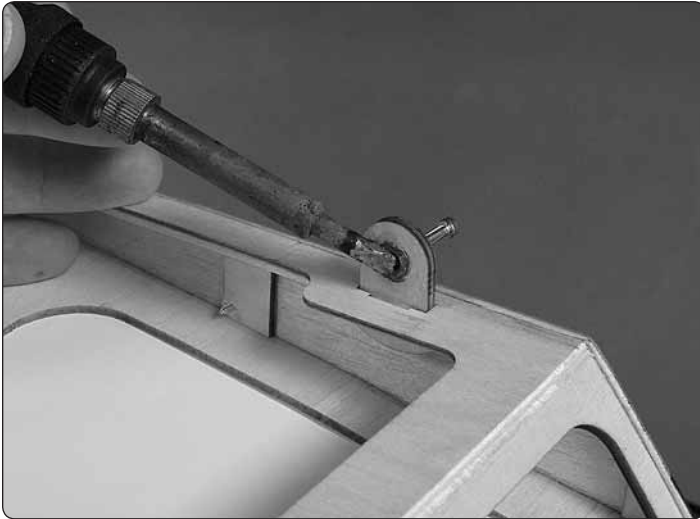
We've encountered a few instances in which the blind nuts in the canopy hatch do not align with the holes in the fuselage making it difficult to install the canopy hatch screws. The quick, easy fix is to relocate the blind nuts as illustrated:
