TECHNICAL NOTICE

HMXE04**ADDN02

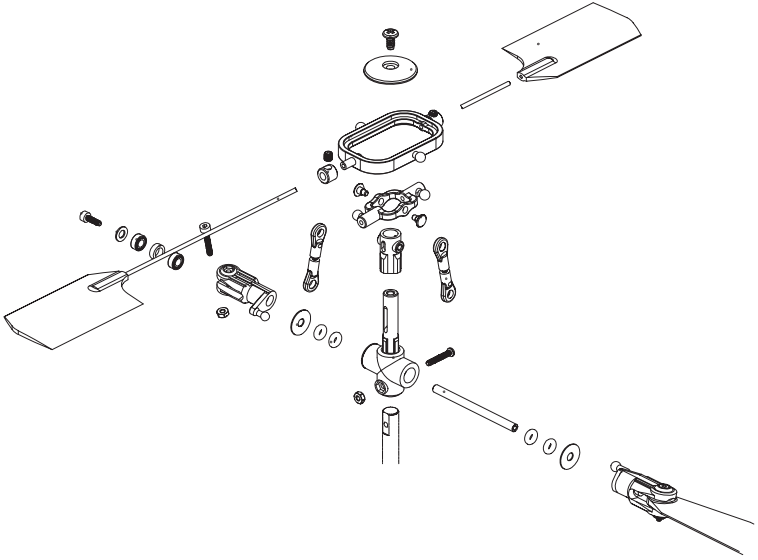
Please note there is an error on the original Exploded View for the Heli-Max AXE CP. The orientation of the main rotor grip shown on the original exploded view is incorrect. Please use this drawing when working on, repairing or reassembling the main rotor head. We apologize for any inconvenience this may have caused.
