Copyright © 2009 GPMA1133Tech01

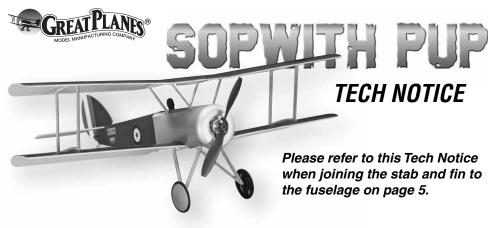
When test-fitting the stab/fin assembly to the fuselage as shown in step 2, check to see if there is a gap between the rudder and the fuselage. If a gap does not exist, proceed with assembly as instructed in the manual. If there is a gap, trim the top of the fuselage as described below.

Use a straightedge and a sharp hobby knife to trim end of the fuselage top as necessary to close the gap—typically removing 1/16" to 3/32" [1.6–2.4mm] is suitable. This will bring the stab/fin assembly forward, eliminating the gap.
